YOUR ONESURVEY  
**HOME REPORT**

25/4  
Pretend Street  
Edinburgh  
EH6 4BY

# SINGLE SURVEY

A report on the condition of the property, with categories being rated from 1 to 3.

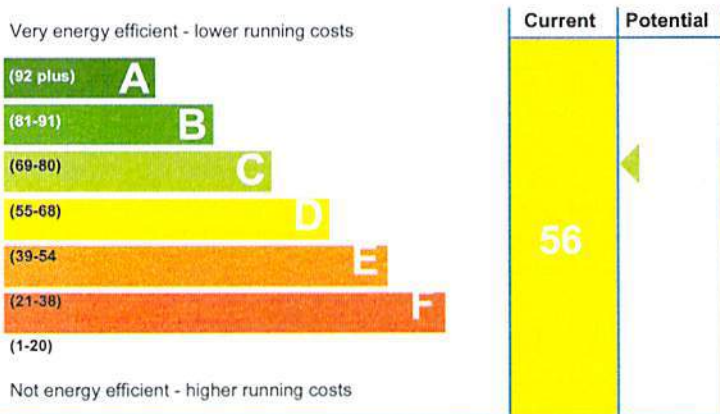
## Energy Efficiency Rating

This graph shows the current efficiency of your home, taking into account both energy efficiency and fuel costs. The higher this rating, the lower your fuel bills are likely to be.

Your current rating is **band D (56)**. The average rating for EPCs in Scotland is **band D (61)**.

The potential rating shows the effect of undertaking all of the improvement measures listed within your recommendations report.
